THE DEVELOPMENT OF A LOW-COST, LEAD-FREE WELLPOINT DRILLING SYSTEM FOR USE IN HOUSEHOLD WELL SYSTEMS IN COASTAL AREAS OF MADAGASCAR

A Thesis Submitted to the Graduate Faculty
of Mercer University School of Engineering
in Partial Fulfillment of the
Requirements for the Degree

2015

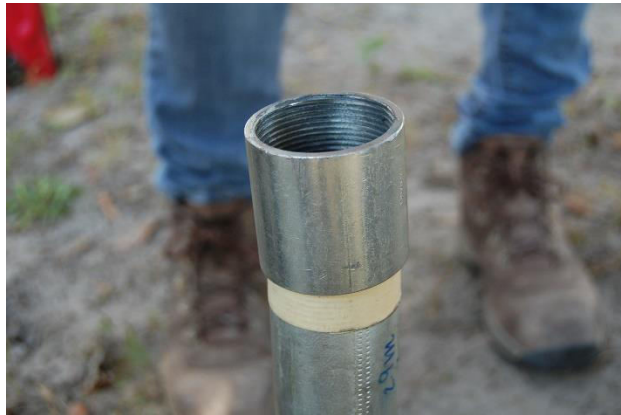
section of the pipe that was being hammered) and the first 10 ft section pipe were examined. As *Figure 21* shows, the connection between the buffer pipe and the 10 ft section pipe was bent at the drive coupling. The buffer pipe was removed and the 5 ft section was added. Plumbers' tape was wrapped around the male threads of the 5 ft drive casing to add support and stability between the threads. Hammering was restarted and eventually stopped at a depth of 3.5 m (11.15 ft).

Figure 21. Bent Drive Coupling

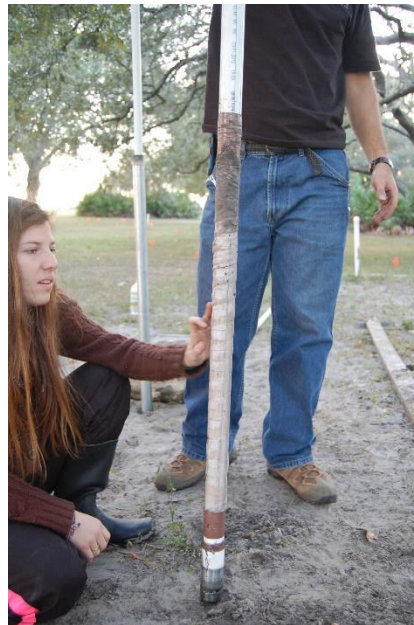
Well #2. Wells #2-5 utilized Exposed-Screen System A. Well #2 was drilled and then removed from the ground successfully. Exposed-Screen System A showed no visible damage to the exterior, and the breathable sleeve was still in place, as it had been before the well was drilled. *Figure 33* shows Exposed-Screen System A for Well #2 after drilling.

Figure 33. Exposed-Screen System A after Drilling

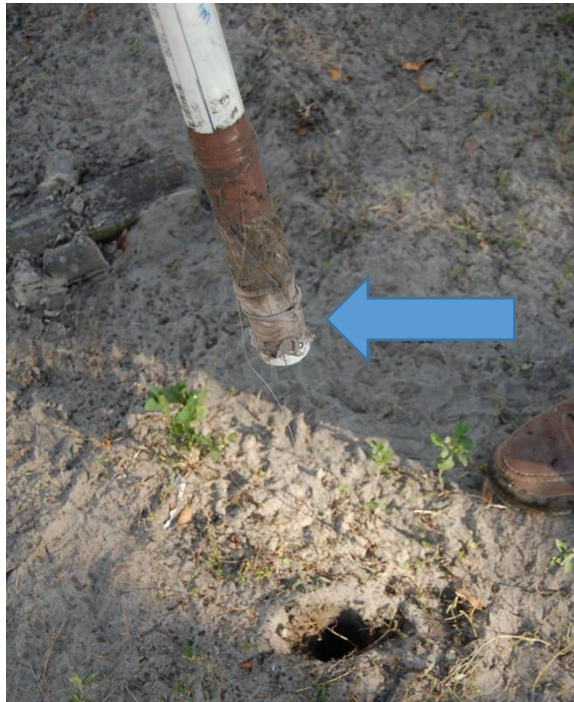
screen was a clean break. Two causes were thought to have contributed to the breaking of the PVC pipe:

Figure 34. Break in Pipe for Well #3

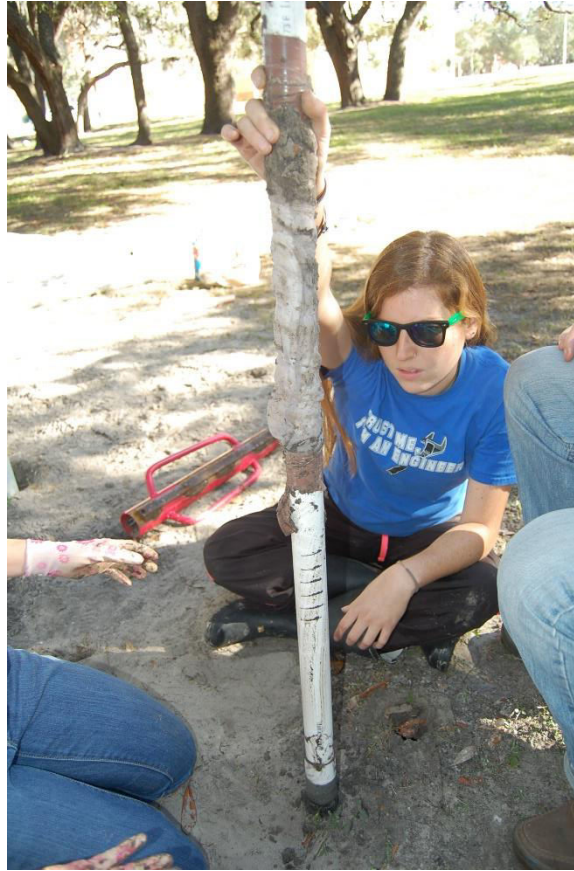
Well #4. Well #4 posed no problems during the coring and hammering phases. However, after removing the pipe from the ground, it was observed that the breathable sleeve was noticeably pushed up. (*Figure 35* shows the sleeve pushed up for Well #4). This likely happened during the hammering process. The sleeve had been made for a 1.5 in. diameter PVC pipe; and the pipes that were being used in drilling were 1.25 in. in diameter. However, when the sleeve was taped to the pipe, the tape may have been too high up on the pipe, which could have allowed dirt or roots to get under the tape during the drilling process. The pipe for Well #2 did not have a pushed up sleeve; however, in that case the sleeve had been taped closer to the male PVC adapter.

Figure 35. Sleeve Pushed Up on Well #4

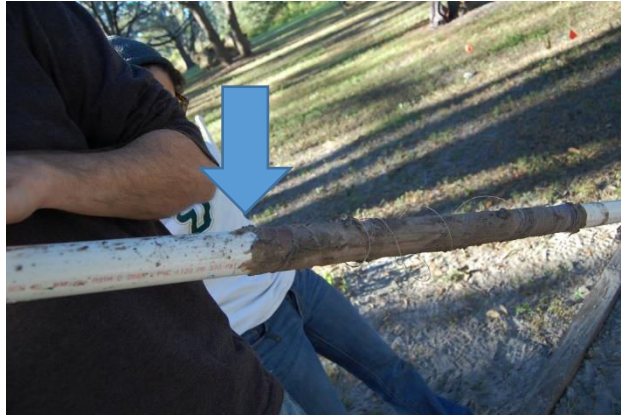
Well #5. A few changes were made in the preparation for the installation of Exposed-Screen System A for Well #5. A stronger pipe was used (Schedule 40 pipe instead of Schedule 20), notches were made above and below the screen, and the bottom portion of the breathable sleeve was taped directly above the male adapter. Toward the end of the drilling process, the end of the pipe broke off at the threads of the male adapter, and the drive coupling and well-point were lost. Upon retrieval of the system, the sleeve was found to be pushed up over the screen, similar to what had happened in Well #4. Pictures of the remaining drilling system are shown in *Figure 36* and *Figure 37*.

Figure 36. Failed Screen on Well #5

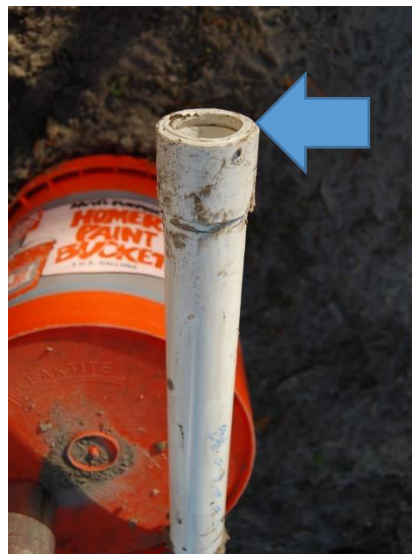
Figure 37. Failed PVC Adapter on Well #5

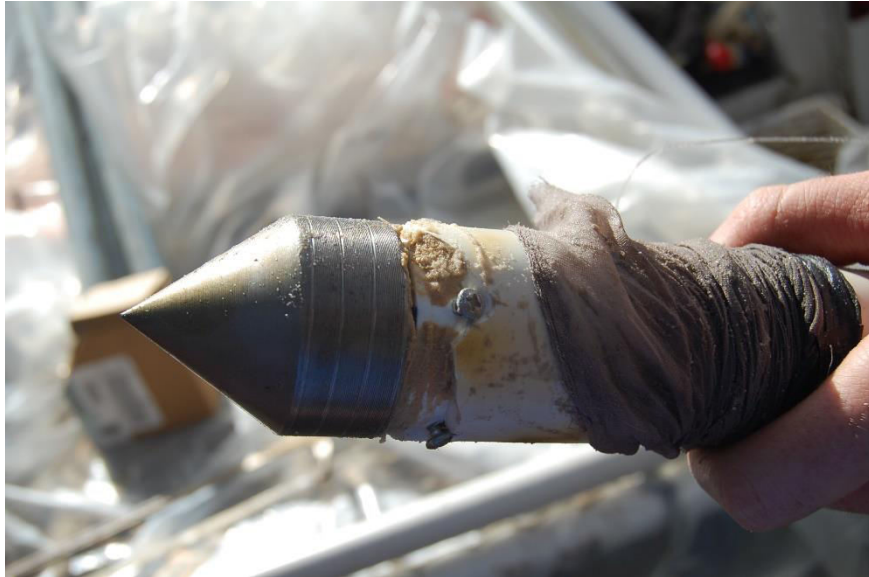
Wells #6 and #7. Wells #6 and #7 were hammered using Schedule 40 PVC pipe with Schedule 20 on the inside of the belled-end. The same modifications that were used during drilling of Exposed-Screen System A were made on the new Exposed-Screen System B in Well #6. The goal of Well #6 was to test the new drilling system to make sure that the well-point did not break off from the rest of the system. Analysis of the PVC pipe pulled from the ground after drilling Well #6 revealed that the Schedule 40 portion of the belled-end was not broken off but was cracked at the edge, where screws had been placed to hold the well-point in place. Additionally, there was a piece chipped off in approximately the same area. It appeared that the screws may have caught on something as the pipe was being hammered down, which may have put pressure on the screws and caused the screws to bend and crack the PVC. Also, the tape did not hold, and the sleeve was pulled down towards the well-point. Analysis of the interior of the PVC pipe showed mud and soil filled the bottom portion of the PVC pipe. *Figure 38 and Figure 39* show the remains of Exposed-Screen System B for Well #6.

Figure 38. A Broken and Cracked Belled-End

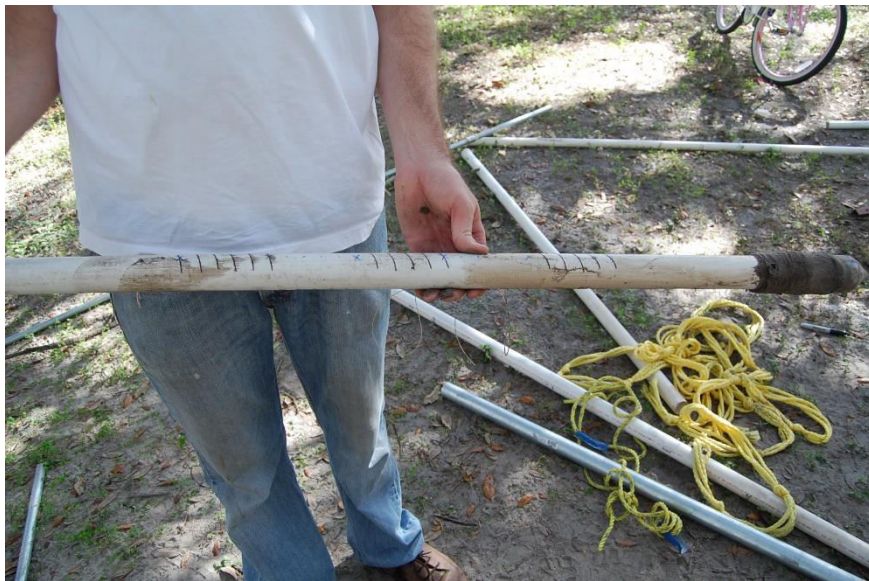
Figure 39. Sleeve Pulled Down on the Belled-End

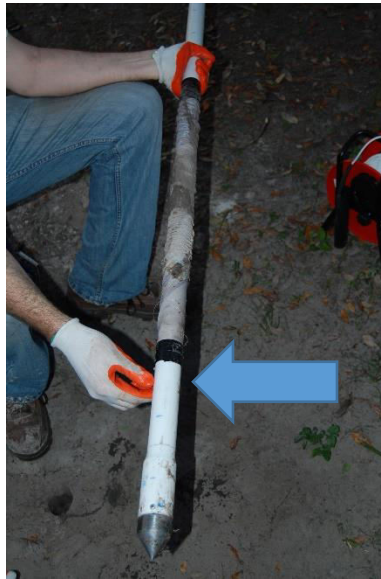
immediately after the belled-end. In addition, the pan-head screws on the belled-end of the pipe were filed down, and shorter strokes were made during the hammering process. After the hammering process the system was removed. No visible external damage to the belled-end of the pipe or the screws was found; however, the sleeve was pushed up about 0.25 m. *Figure 40* shows the PVC pipe after drilling Well #7.

Figure 40. PVC Pipe after Drilling Well #7

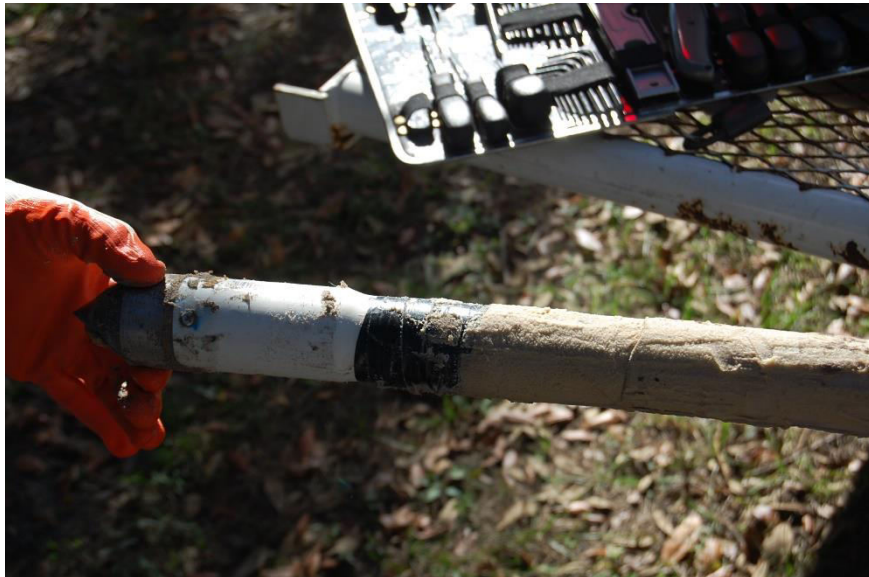
breathable sleeve. Additionally, the length of each stroke was set at 15 cm, to minimize vibration that could disturb the PVC where it is attached to the well-point. After hammering, the PVC pipe was removed from the ground. There appeared to be no external damage to Exposed-Screen System B, and the sleeve remained in the same location as it was before the drilling process began. *Figure 41* shows Exposed-Screen System B after drilling Well #8.

Figure 41. Exposed-Screen System B after Drilling Well #8

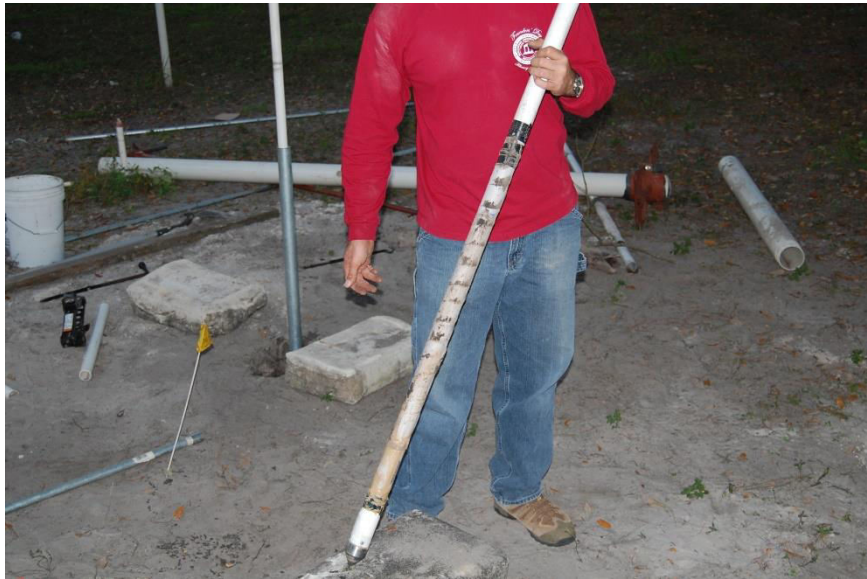
place and had not moved during the hammering process. *Figure 42* shows the PVC pipe after drilling Well #9.

Figure 42. PVC Pipe after Drilling Well #9

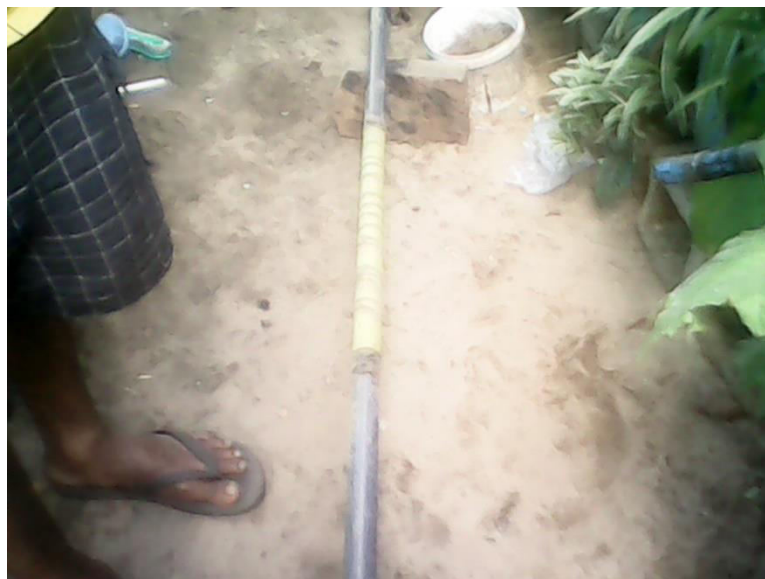
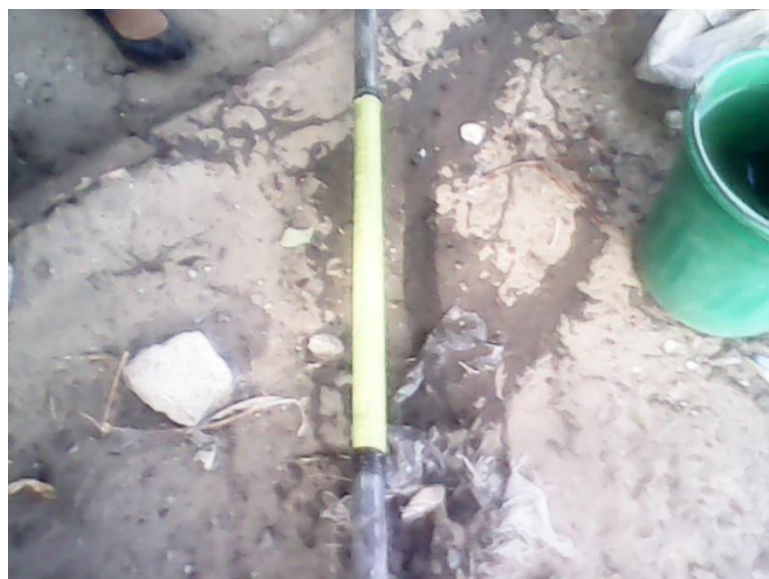
Deconstruction. Almost one week passed before the wells were deconstructed. Both wells were deconstructed and removed from the ground without any issues. The well-points for both systems were left in the ground, and the PVC pipes and GI drive pipes were examined. The breathable sleeves on both wells did not appear to have any damage and were not pushed up. The breathable sleeves were then removed and the slots on the PVC pipes were examined. Just like Wells #8 and #9 in Phase II, there appeared to be no damage to PVC pipes or the GI drive pipes. The PVC pipes of the deconstructed systems can be seen in *Figure 43 and Figure 44*.

Figure 43. PVC pipe of Well #1 of the Madagascar System

Figure 44. PVC pipe of Well #2 of the Madagascar System
