# THE DEVELOPMENT OF THE ROPE AND WASHER PUMP FOR USE WITH TUBEWELLS IN MAPUTALAND, SOUTH AFRICA

**THE DEVELOPMENT OF THE ROPE AND WASHER PUMP FOR  
USE WITH TUBEWELLS IN MAPUTALAND, SOUTH AFRICA**

A dissertation submitted in partial fulfilment of the degree of  
MSc in Engineering for Development  
by instructional course.  
February 2004

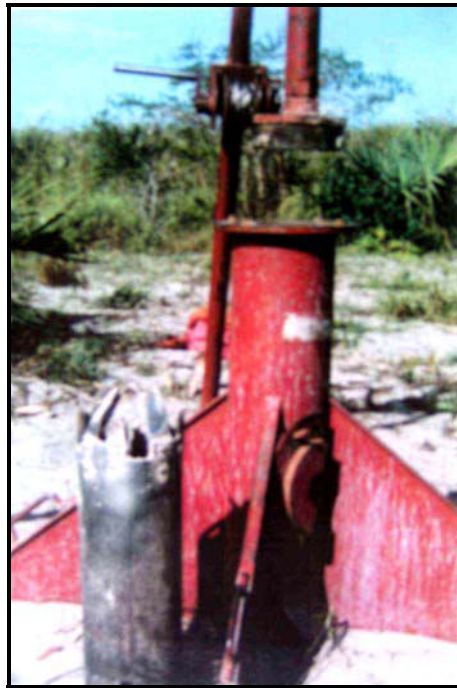
**Figure 2.2** Photo Showing Vonder Rig Auger, Worktable, and Tripod Winch

The manual auger that is used in the UFWP, the Vonder Rig, was developed by V & W engineering of Zimbabwe. The main components of the Vonder Rig can be seen in Figures 2.2 and 2.3. The Vonder Rig consists of a steel tripod from which drilling rods are hung. A robust worktable aligns the extension rods of the auger as it drills into the ground. A winch, which is attached to one of the tripod's legs, is used to raise and lower the auger. The Vonder Rig is capable of drilling through soils and weathered rock formations. However, it is not possible to drill through hard rock (Morgan, 1990). The sandy soil found throughout Maputaland makes drilling with the Vonder Rig relatively easy, with water table depths of up to twenty metres achievable within six working days (Deverill et al., 1999b).

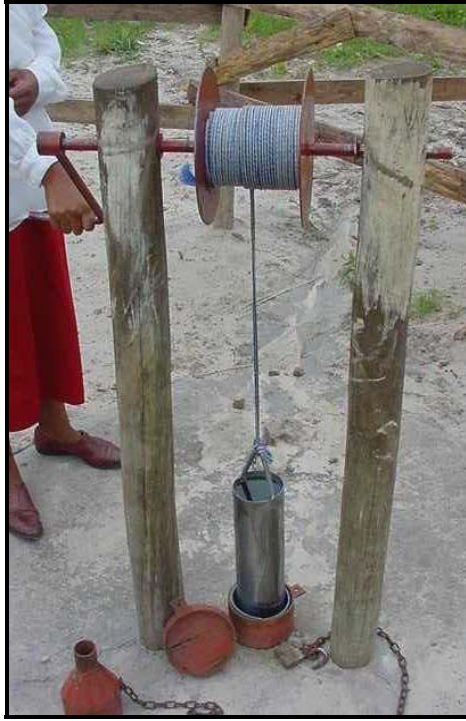
**Figure 2. 4 Bucket Pump being lowered into tubewell**

The UFWP uses a Bucket Pump system, which consists of a long, narrow bucket attached to a rope and windlass (a horizontal cylinder with a crank), as shown in Figures 2.4 and 2.5. The bucket is lowered to the bottom of the well on the rope to collect water, and then wound to the surface.

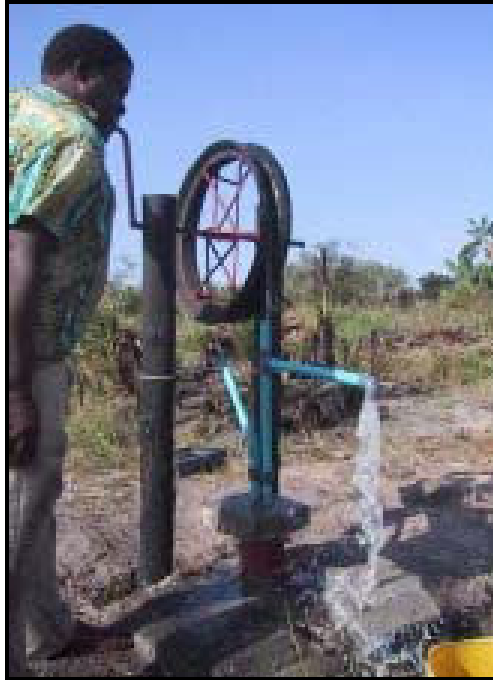
**Figure 5.2 Photo of reference R & W Pump in use (Garden Pump)**

The pulley wheel and supports consist of a wheel and handle supported by two gum tree poles, as shown in Figure 5.1 and Figure 5.2. The wheel is constructed from the sidewalls of a salvaged 20-inch (510-mm) diameter truck tyre, as described in Chapter 3. The rim of the wheel is fabricated from mild steel, which is welded together on a jig to maintain the circular shape of the wheel. The use of gum tree poles as supports for the pulley wheel was adapted from the UFWP Bucket Pump model, in order to make use of locally available materials. A braking system for the pulley wheel is attached to one of the poles, and acts as a safety mechanism to prevent people from being hit by the moving handle as the pulley wheel moves backwards. The brake makes contact with pegs that are welded perpendicular to the rim on the pulley wheel, which allows the wheel to move only in the direction of pumping. Figure 5.3 shows the pulley wheel braking system.

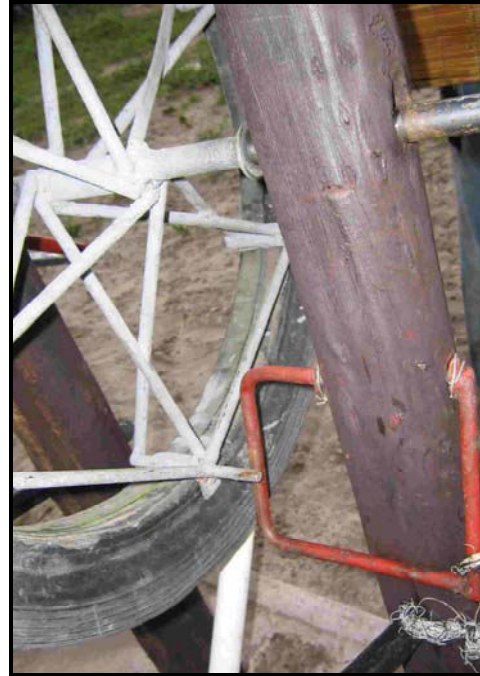
**Figure 5.3 Photo of pulley wheel braking system. Pegs (grey) on pulley wheel make contact with the brake (red).**

The brake's function is to prevent the pulley wheel from turning in the direction opposite to the pumping direction, as the pulley wheel is released. This happens as the remaining water in the rising main pipe forces the washers downward in the opposite direction to the pumping direction. When in the operating position, the brake makes a loud sound as it hits each peg during pumping, which can be aggravating to the user. The majority of users of the reference R & W Pumps have found the use of the brake during pump operation to be annoying, and decided to disengage the brake during pumping, and then set it back to its working position as soon as pumping was completed (*i.e.* before the pulley wheel turns backwards).

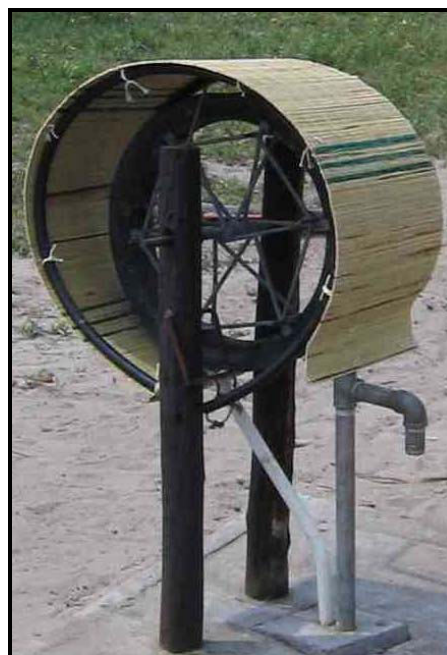
**Figure 5.11** Photo of Maputaland Hygienic Cover with new hand-made Zulu mat (Thwala Pump)

The frame of the hygienic cover can be effectively covered with a straw mat (Figure 5.11), which is a common Zulu craftwork in Maputaland. These mats can be bought at most village markets in the area, and are very reasonably priced. A mat large enough to make two covers can be bought for R10-R20, depending on

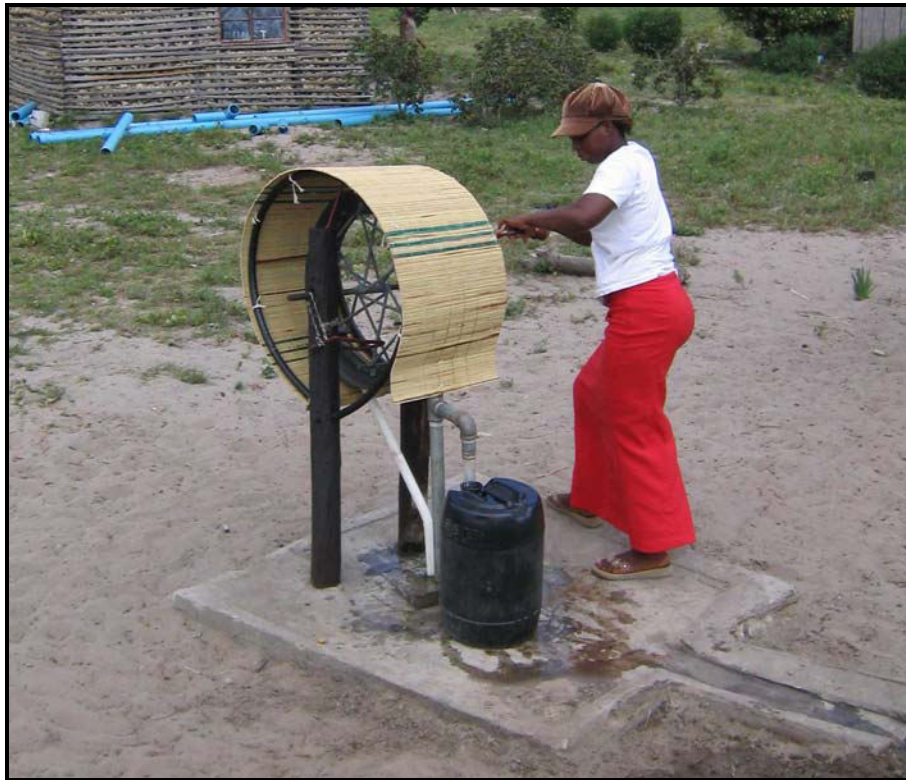
Figure 5.12 Photo of final project design of the R & W Pump in use (Thwala Pump)

The development of the R & W Pump for use with tubewells in Maputaland has led to a final project R & W Pump design that is believed to be acceptable for the remaining pumps to be built and installed for the UFWP. This design is robust and requires minimal routine maintenance. Figure 5.12 shows the final design of the R & W Pump for tubewells in use.

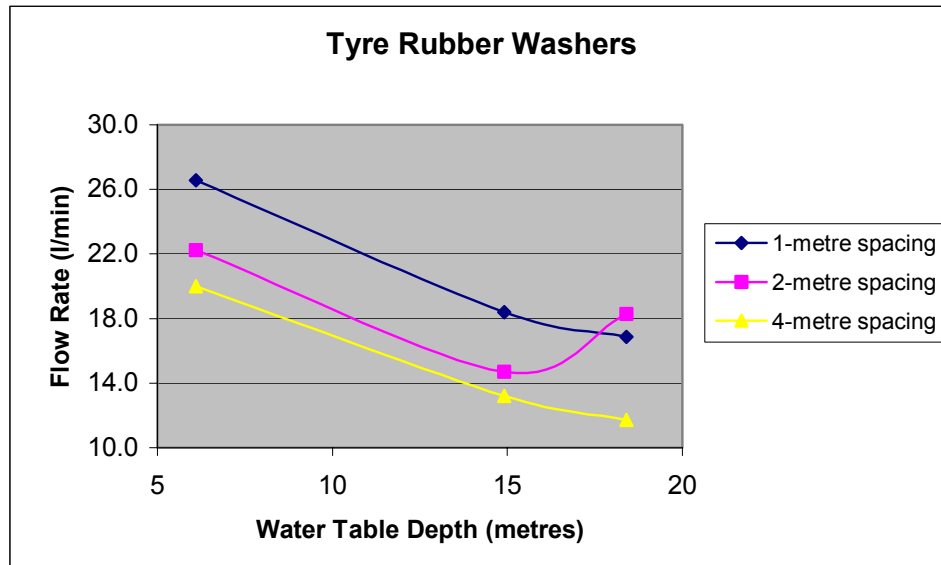
**Figure 6. 1 Pumping Rates at Various Spacings for Tyre Rubber Washers**

Figure 6.1 shows the pumping performance when using tyre rubber washers. Pumping rates varied from 12 litres/minute when pumping from the deepest well and using washers spaced at 4-metre intervals, to 26 litres/minute when pumping from the shallow well with washers spaced at one-metre intervals. At each pump depth, the difference in pumping rates for the three washer configurations varied by 5 to 6 litres/minute.

However, the rope with washers spaced at two-metre intervals performed better on the deep well. This situation was also experienced during the monitoring of two of the deep reference R & W Pumps (Thwala Pump and Pateni Pump). While the tyre rubber washers spaced at one-metre intervals decrease the amount of losses within the pipe (compared to larger spacings), each washer is also causing friction within the pipe. For deep wells, the combined friction of all washers makes pumping difficult. Therefore, the increased spacing of two-metres decreases the friction within the pipe by half, leading to a higher pumping rate.

Based upon the collected data, it is recommended that tyre rubber washers be spaced at one-metre intervals for shallow or medium depth pumps, and at two-metre intervals for deep pumps.

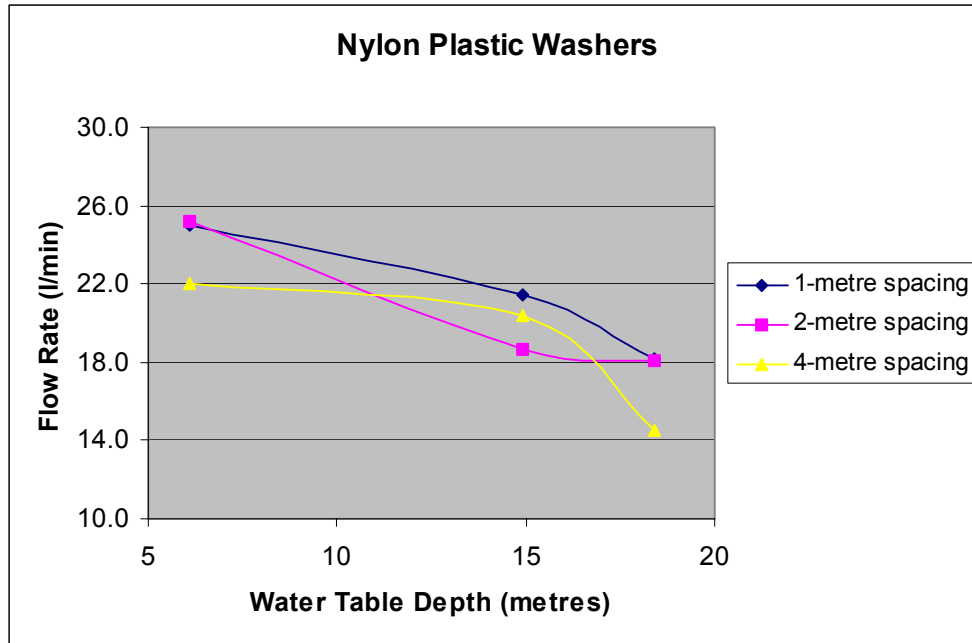
Figure 6.2 Flow Rates at Various Spacings for Nylon Plastic Washers

Figure 6.2 shows the pumping performance when using nylon plastic washers. These pumping rates varied from 14 litres/minute, pumping from the deepest well using washers spaced at 4-metre intervals, to 25 litres/minute when pumping from the shallow well with washers spaced at two-metre intervals. At each pump depth, the difference in pumping rates for the three configurations varied by 3 to 4 litres/minute.

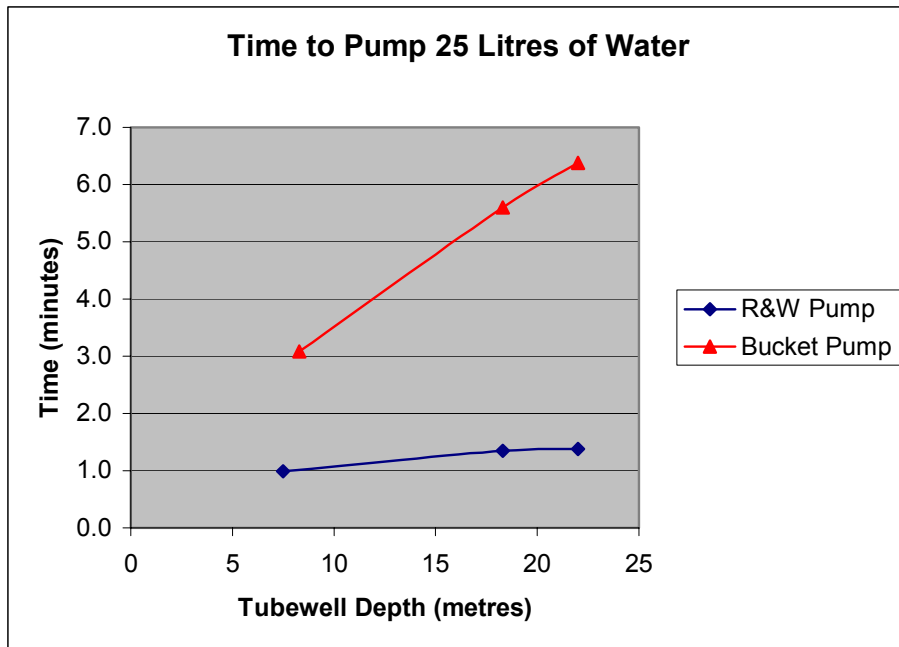
**Figure 6.3 Pumping time Comparison of R & W Pump to Bucket Pump**

Figure 6.3 shows the time taken to pump 25 litres of water from the pumps at various depths for the R & W Pump (average of times for pumps using tyre rubber washers and nylon plastic washers) and the Bucket Pump.

It can be seen from Figure 6.3 that there is a large difference in pumping times. It is assumed that a family of six uses an average of 50 litres of water per person per day, which can be expected when water is supplied to a yard level (WHO, 2003). This quantity of water would require daily pumping of between 36-80 minutes using a Bucket Pump, depending on the pump depth. Pumping the same amount of water from the R & W Pump requires 12-18 minutes, and saves roughly 25-60 minutes of pumping daily. The effect of the user taking breaks during pumping, because of fatigue, would further increase the time differences.

These data show that the efficiency of the R & W Pump over the Bucket Pump increases with water table depth. From these data, the R & W Pump is estimated to be three to five times more efficient than the Bucket Pump. For each of the three water table depths, both of the testing subjects also reported that they were considerably more fatigued after pumping 25 litres of water from the Bucket Pump compared to pumping the same amount using the R & W Pump.
